# Beheersing van voedselpathogenen in de vers vleesketen van varkens

Geertrui Rasschaert

Studienamiddag 9 mei 2023

# Identification of the Source for *Salmonella* Contamination of Carcasses in a Large Pig Slaughterhouse

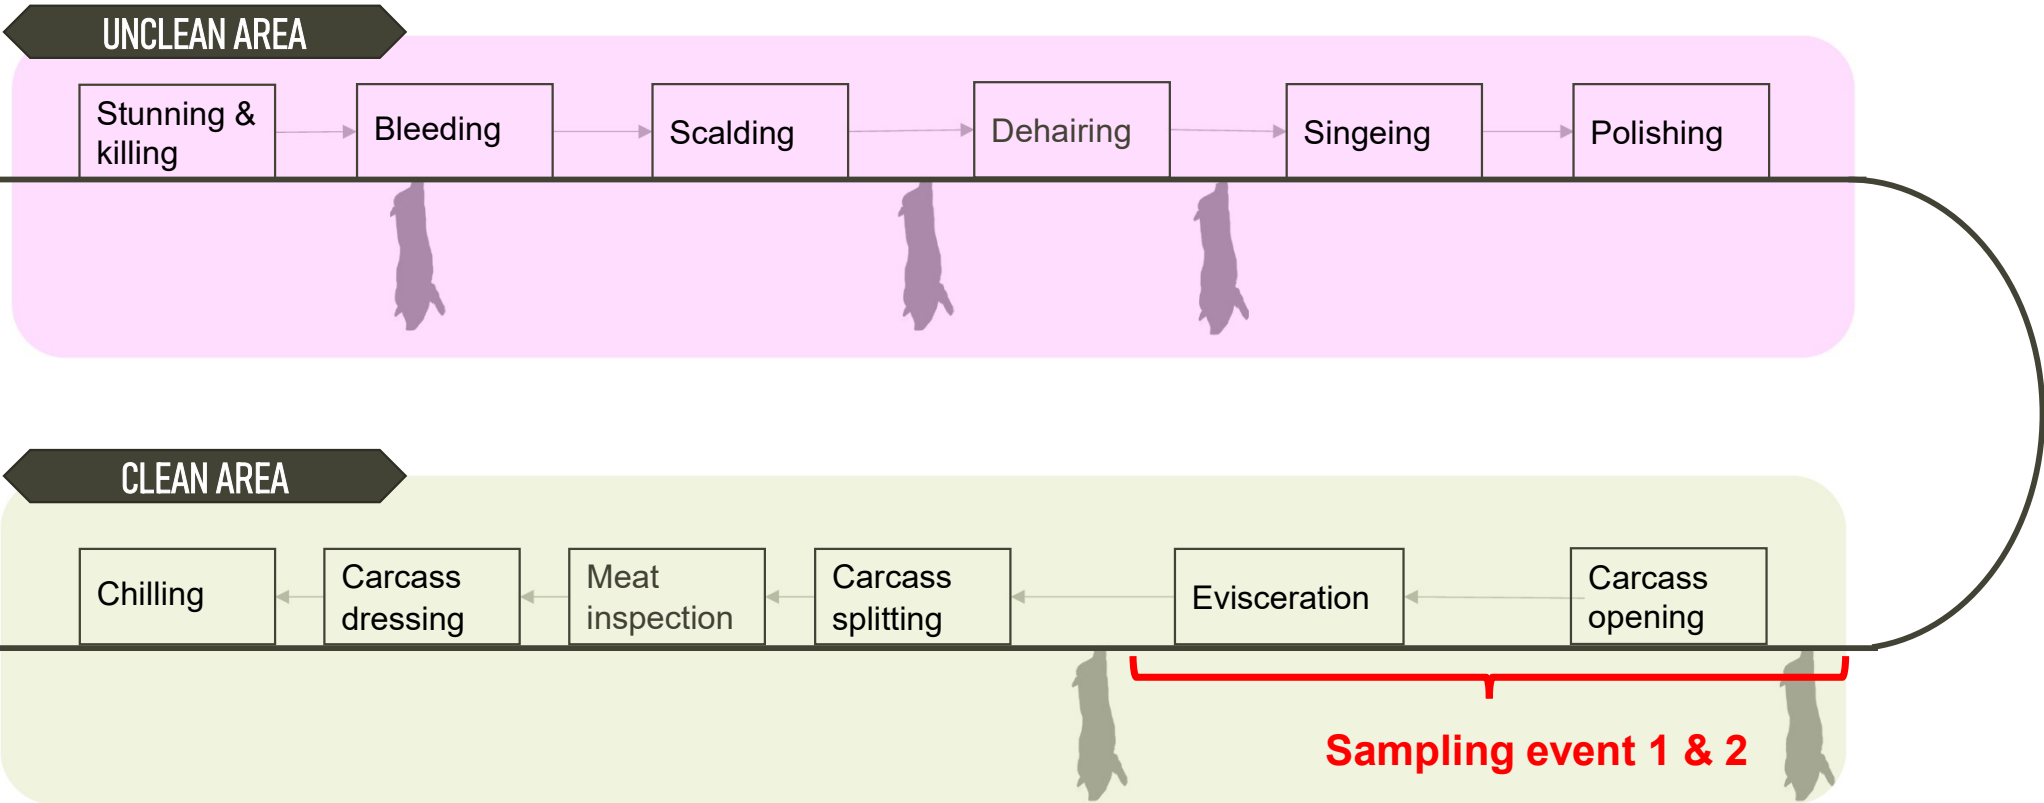
**Sampling event 1 & 2**

**UNCLEAN AREA**

Stunning & killing

Bleeding

Scalding

Dehairing

Singeing

Polishing

**CLEAN AREA**

Chilling

Carcass dressing

Meat inspection

Carcass splitting

Evisceration

Carcass opening

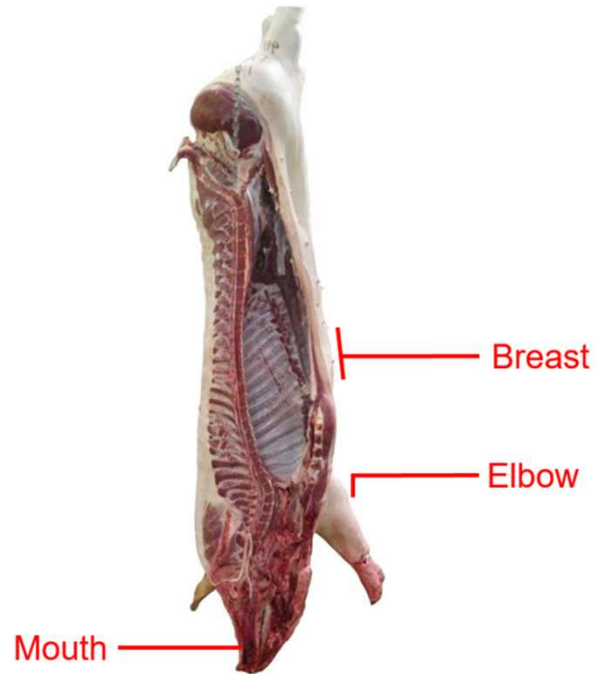
## Sampling event 1 & 2

### SAMPLING LOCATIONS

1. mouth swabs + carcass swabs, LEFT (brisket; elbow)
2. intestines / rectum content
3. carcass swabs, RIGHT (brisket; elbow)

Before evisceration		After evisceration	
Breast	Elbow	Breast	Elbow
3/30	3/30	2/30	0/30

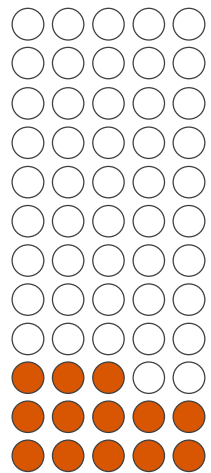
Positive carcasses

21%  
(13/60)  
*L. mono*

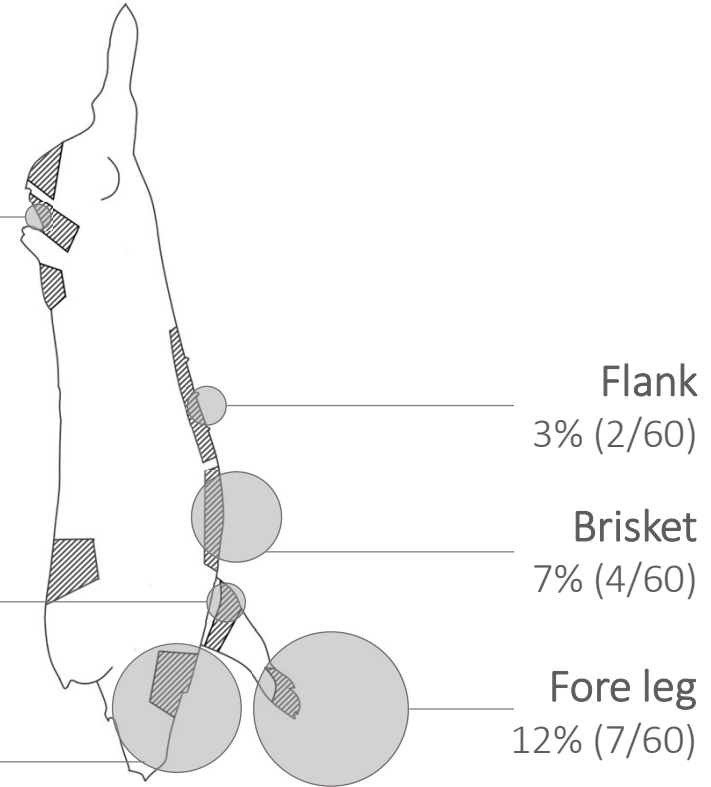
Location

Pelvic duct  
2% (1/60)

Elbow  
3% (2/60)

Throat region  
10% (6/60)

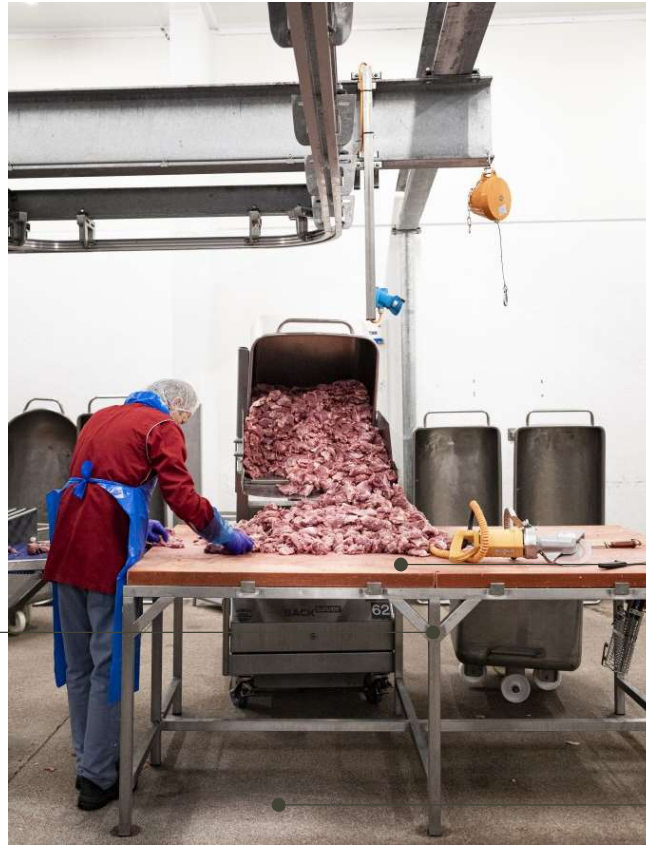
During  
production

Type 2  
NFCS close to product contact surface

Type 1  
Food contact surfaces  
(FCS)

Type 3  
NFCS not close to zone 1

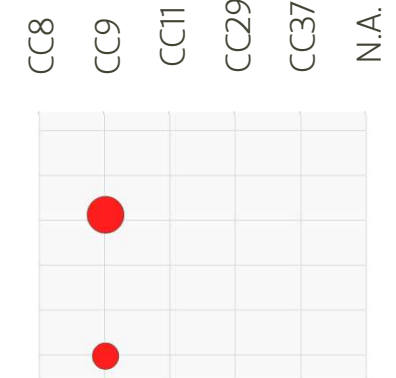
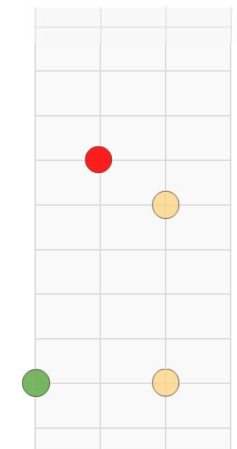
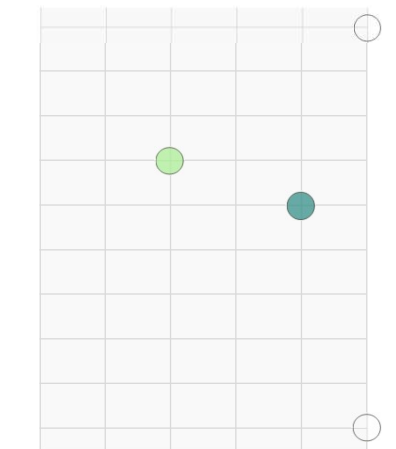
# Type 1 surfaces: after C&D and during production

After C&D: 5% (10/214)

- Circular saw (blade)
- Meat hooks
- Meat cutting table
- Cutting board
- Meat containers (inside)
- Conveyor (belt)

Production: 7% (15/222)

- Carcass divider
- Chainmail (gloves)
- Chopping block
- Meat hooks
- Meat cutting table
- Cutting board
- Conveyor (belt)
- Meat spikes
- Pork skinning peeling machine
- Stainless steel cart

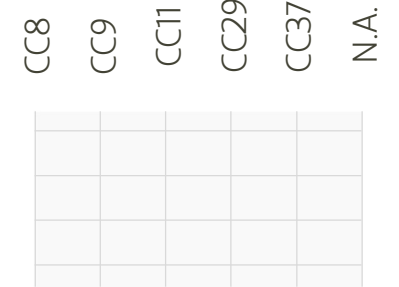
## Type 2 surfaces: after C&D and during production

After C&D: 9% (6/65)

Circular saw (handle)  
Cutting board (handle)  
Meat containers (outside)  
Conveyor (undercarriage)

Production: 8% (7/89)

Circular saw (handle)  
Meat containers (outside)  
Conveyor (undercarriage)  
Conveyor (wheels)  
Plastic apron

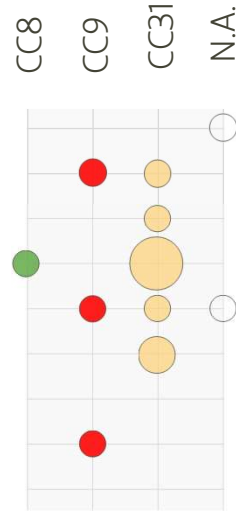
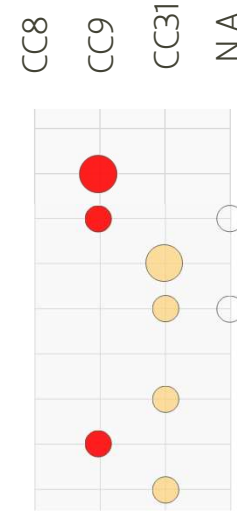
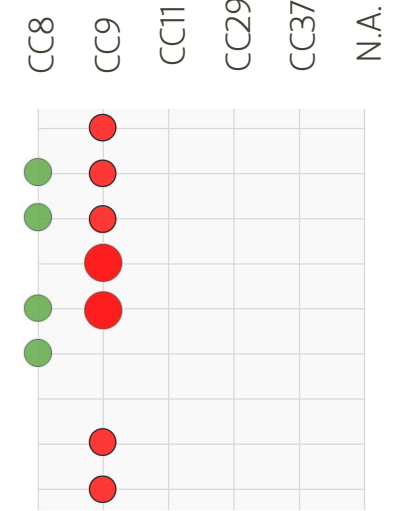
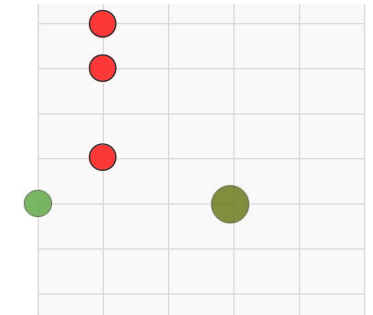
## Type 3 surfaces: after C&D and during production

After C&D: **28%** (41/149)

Pallet truck (handle)  
 Pallet truck (wheel)  
 Plastic transport pallet  
 Floor drain  
 Floor  
 Cleaning material (brush)  
 Cleaning material (shovel)  
 Cleaning material (floor squeegee)  
 High pressure washer (handle)

Production: **24%** (31/129)

Pallet truck (handle)  
 Pallet truck (wheel)  
 Plastic transport pallet  
 Floor drain  
 Floor  
 Handle (door)  
 Round knife wizard
